## **INCORPORATED COUNTY OF LOS ALAMOS RESOLUTION NO. 21-06**

### **A RESOLUTION MAKING CERTAIN FINDINGS AND DETERMINATIONS PURSUANT TO THE METROPOLITAN REDEVELOPMENT CODE, AND DESIGNATING WHITE ROCK DOWNTOWN AS A METROPOLITAN REDEVELOPMENT AREA**

**Exhibit A – White Rock Designation Report 2020**

# White Rock Commercial Center Metropolitan Redevelopment Area (MRA) Designation Report

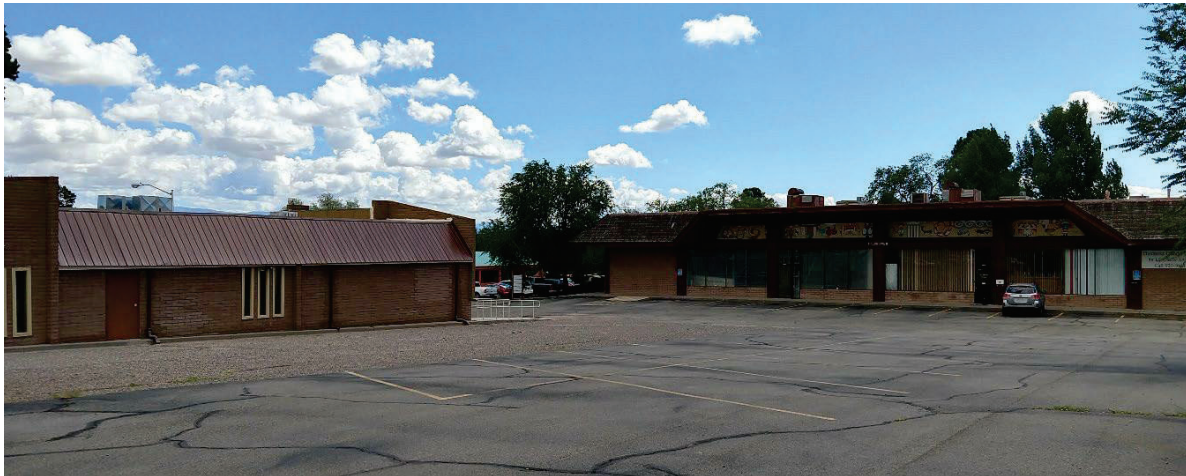
Figure 2. The White Rock Business Plaza site, which currently has several vacant storefronts and buildings that are outdated and need improvements to attract new tenants.

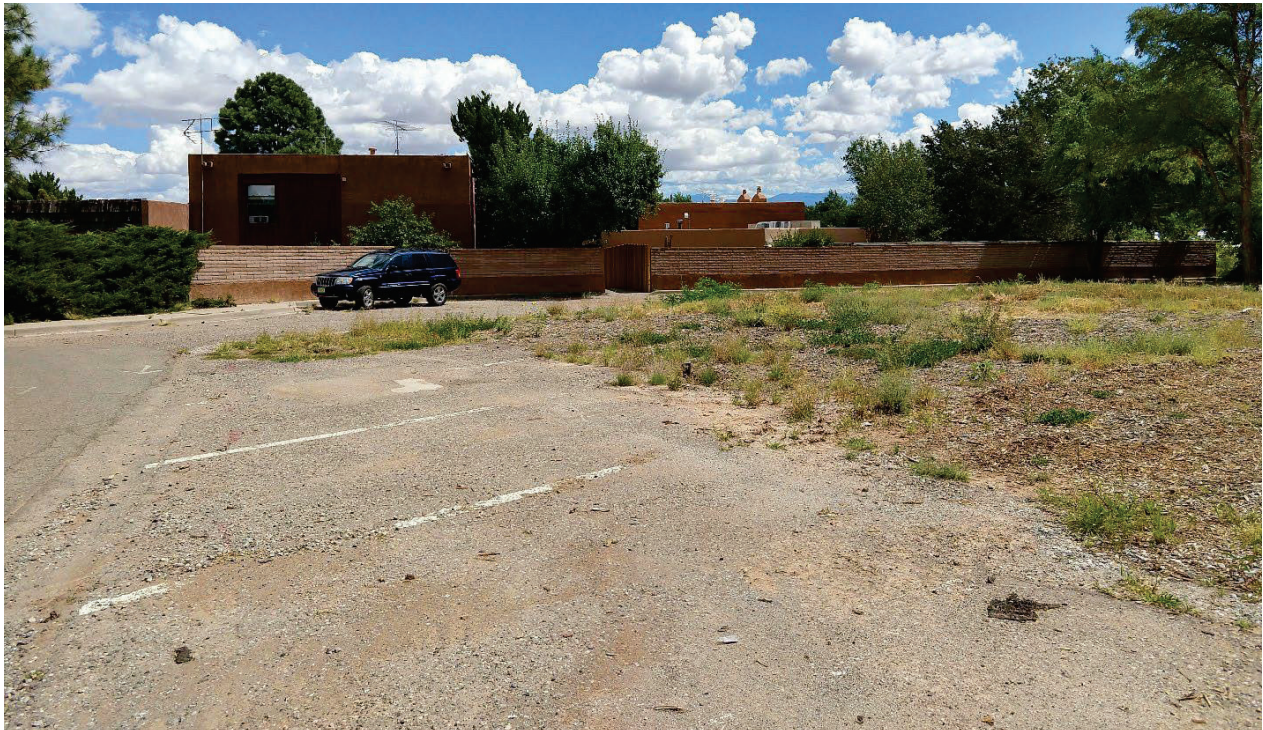
Figure 3. Vacant lot and former parking spaces of lot along Longview Drive.

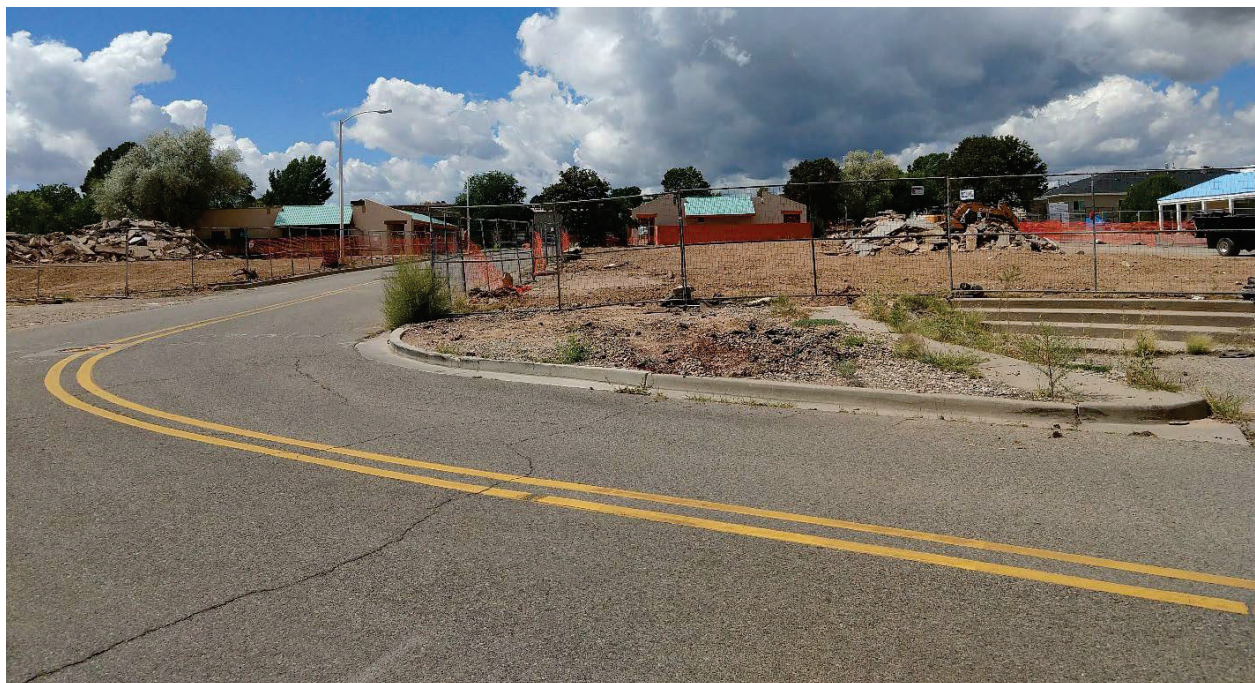
Figure 4. Recently demolished office building site along Longview Drive.

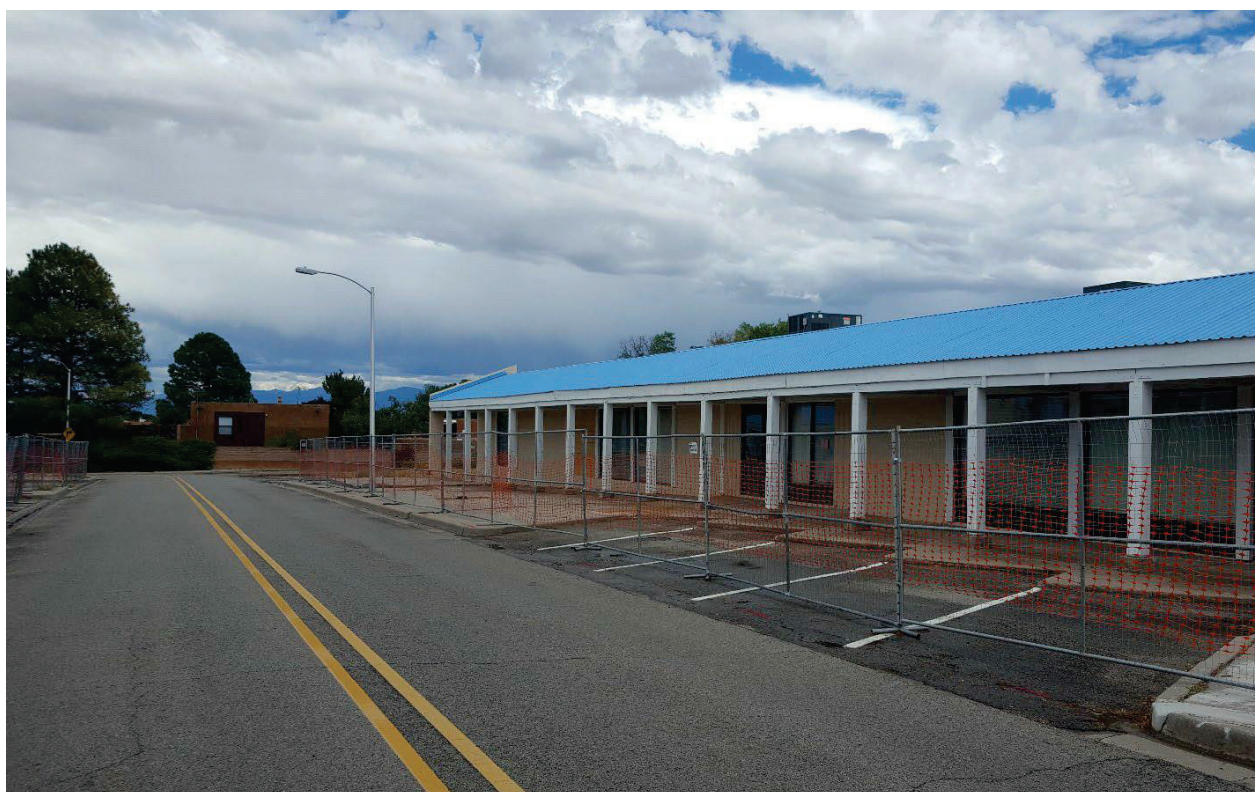
Figure 5. Office building along Longview Drive that was recently demolished due to multiple issues with the building.

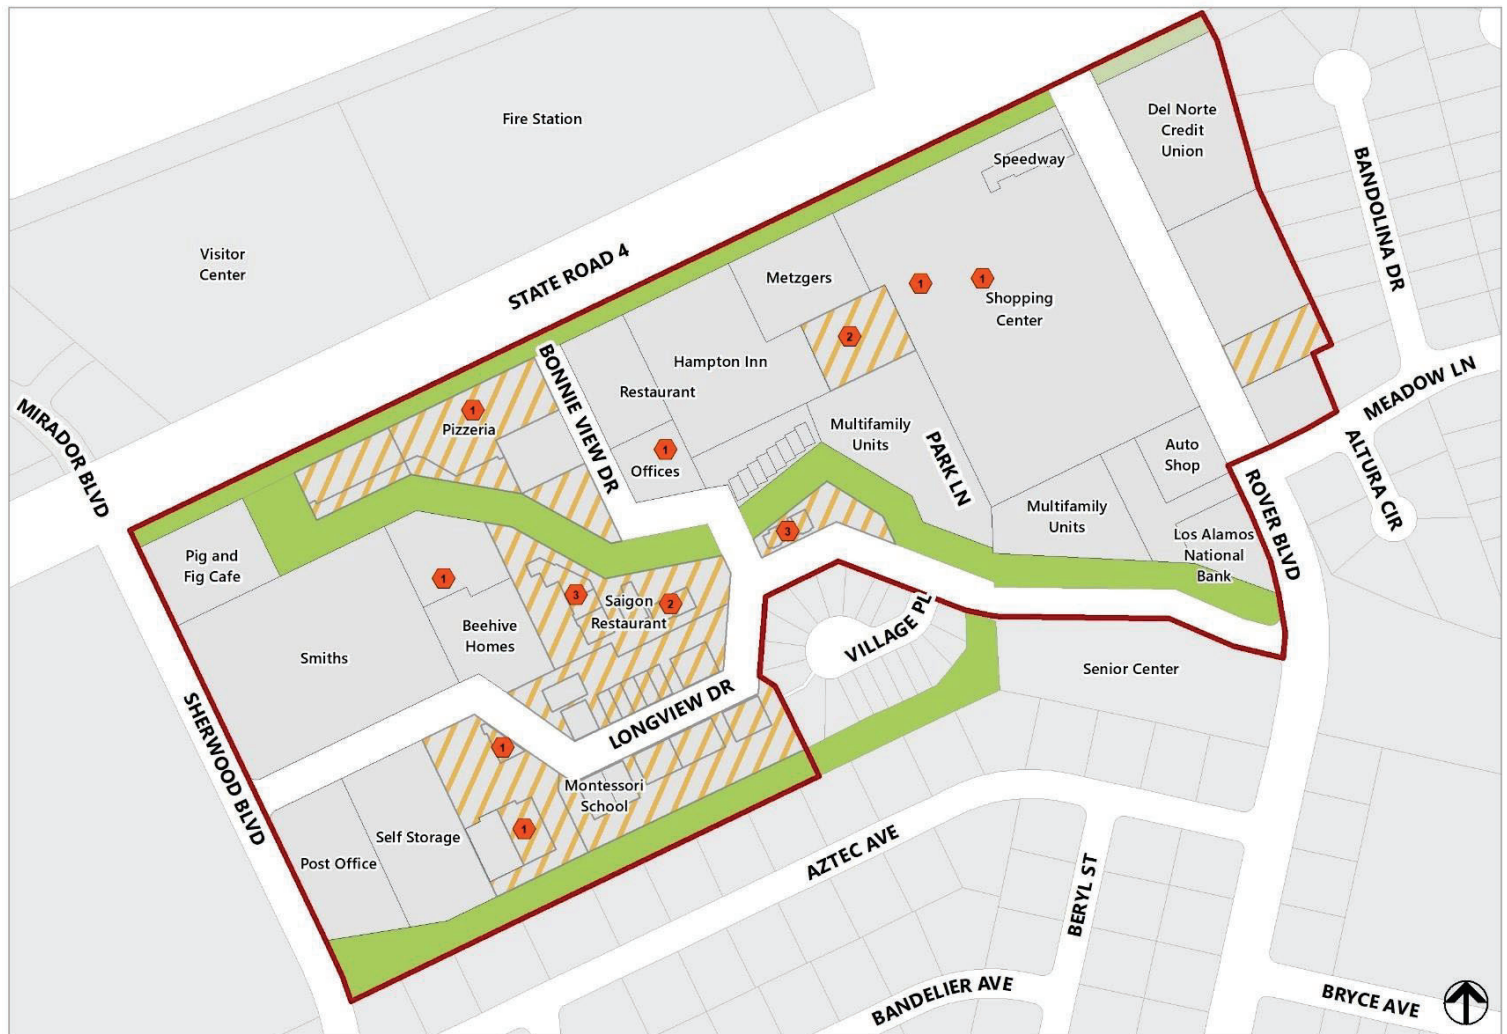
Figure 6. Vacant Sites and Storefronts.

A list of vacant and underutilized buildings observed, include the following, with the approximate number of vacant storefronts indicated in parentheses:

- The White Rock Shopping Center is underutilized, with at least one vacant storefront (1).
- The building currently occupied by the “Northern New Mexico Revival Center” is underutilized (1).
- The office building behind Metzger’s Hardware store is vacant (2).
- The former Time Out Pizzeria (originally a McDonalds) building is closed (1).
- The office adjacent to the Pizza Hut and the bank building on Bonnie View Drive appears to have a vacancy (1).
- A vacant office building at the intersection of Bonnie View Drive and Longview Drive (3).
- Multiple vacant office structures and sites along Longview Drive, including the recently demolished office structures (6).
- The White Rock Business Plaza is underutilized, with at least two storefronts currently vacant (2).

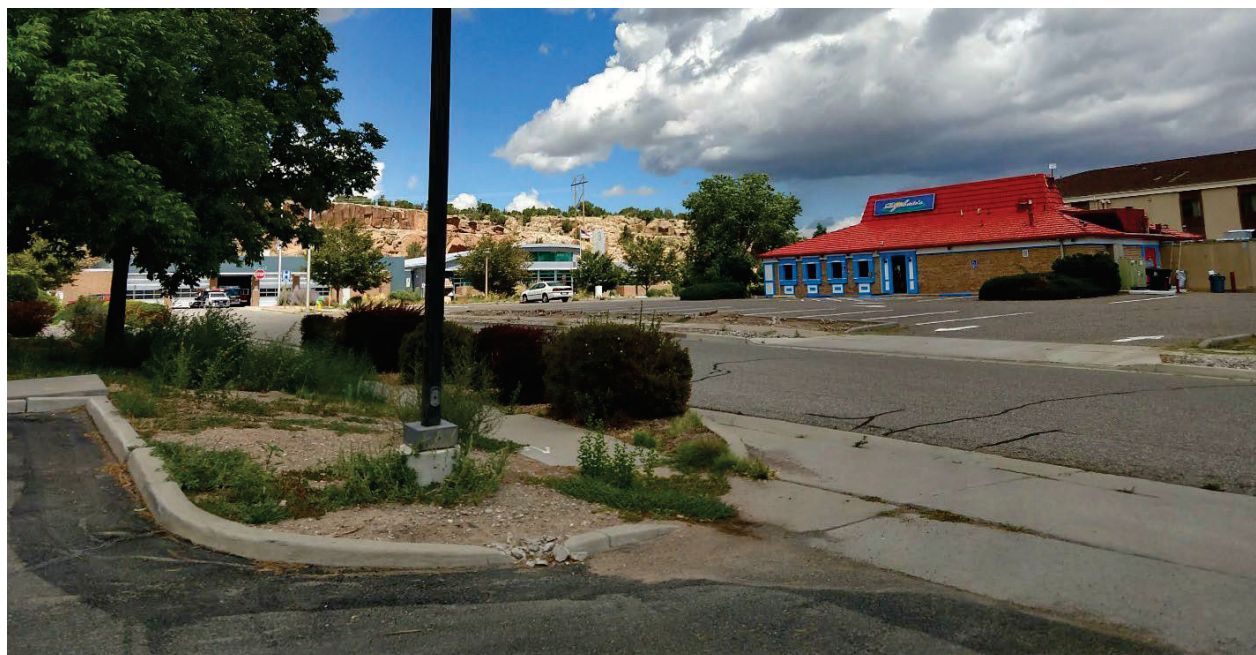
There is a general deterioration of public improvements within the MRA, which includes damaged or missing sidewalks, non-ADA compliant ramps, drainage issues, and unmaintained landscape improvements. For example, there are many missing and/or disconnected sidewalks along Longview Drive, which makes it hard for pedestrians or those with disabilities to navigate this area. In addition, maintenance and care of the arroyo channel and trail could be improved to make this a public amenity.

Figure 8. Degraded site improvements and overgrown landscaped areas along Bonnie View Drive.
